PHOTOGRAPHIC EVALUATION REPORT

Mission 9040
28, 29, 30, 31 July ZFE No. 33-62

<u>PAGE</u>
PART I	FORWARD CAMERA	<u>1-5</u>
PART II	AFT CAMERA	6-10
PART III	FRAMING CAMERA	11-12
PART IV	VEHICLE ATTITUDE DATA	13
PART V	DENSITY CHART	14

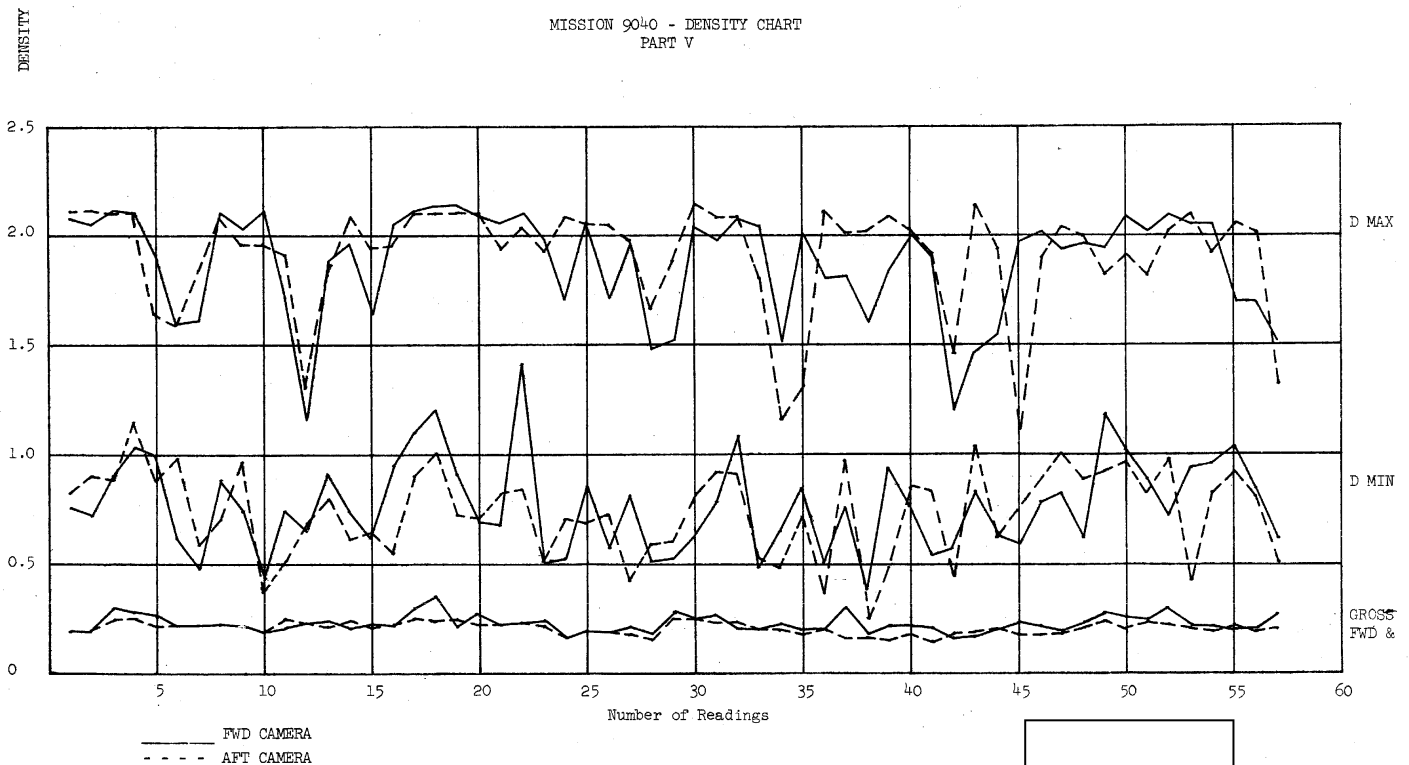
Page 14 of 14

MISSION 9040 - DENSITY CHART
PART V

8. Density readings were made on every pass using the MacBeth Quantalog Densitometer Model EP 1000 with an EP 20 attachment. Absolute values read for D Max and D Min as well as Gross Fog are given below. Uniform Gross Fog readings and static D Max columns have been added to this report in order that degradations of film due to those factors may be made available for further study.
